# Refurbishing Your HF Antenna

By Marinus A. Willemstijn ZS6MAW

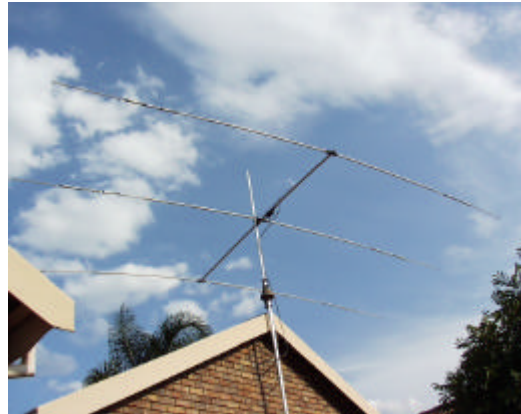
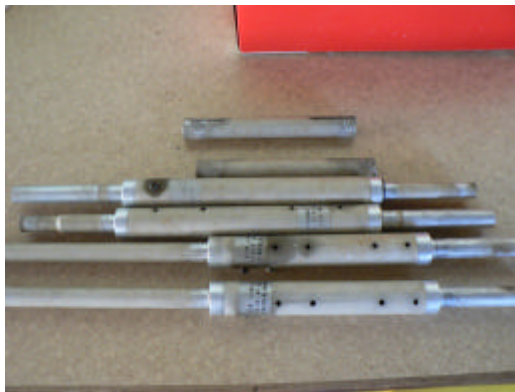
The photographs show the TH3JR and CD45MKII in its last position before it was taken down.

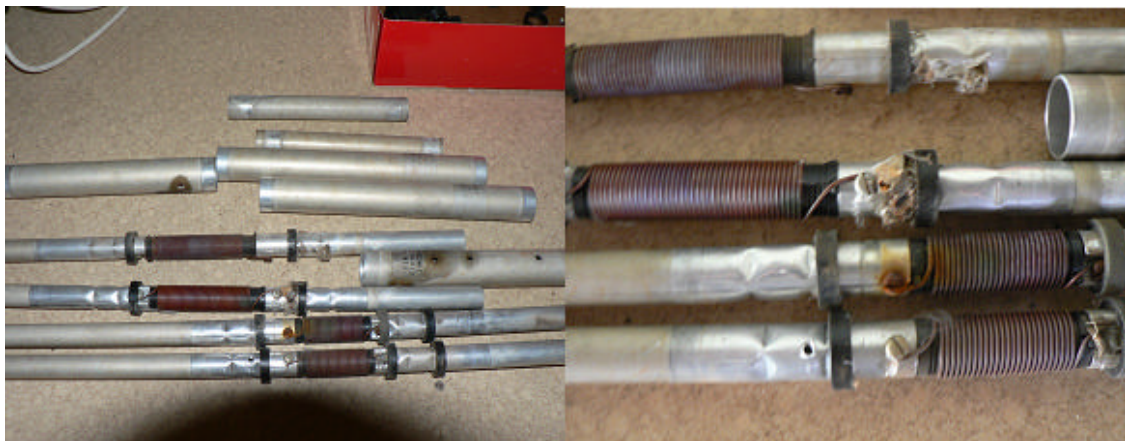
I dismantled the different pieces of the antenna and removed all plastics on the antenna. Part of the dismantling process was opening the traps of the antenna (There are 12 traps on the TH3JR). The traps were each very carefully checked. There

was definite evidence of water corrosion in some of the traps. I used a soft toothbrush with clean water to remove the grit off the windings. Some of the screws used to connect the copper wire of the winding to the aluminum tubing were also corroded. The screws holding down the aluminum trap covers had started to corrode as well and will thus be replaced.

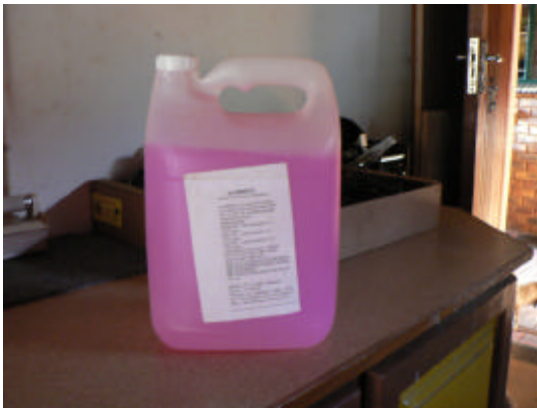
I purchased a cleaning solution called Alumibrite. This chemical was specifically developed to clean aluminum. It is an industrial type chemical that needs to be handled with great care. I used rubber gloves during preparation of the solution and also during the cleaning of the antenna. I prepared the solution in an old bucket with a wider throat than a normal bucket for ease of working. By changing the ratio of Alumibrite to water one can change the aggressiveness of the cleaning agent. I opted for the 9:1 water to chemical ratio which is considered to be a medium strength as per the instructions. I had another bucket with clean water to immediately rinse the aluminum after cleaning. In hindsight I could have saved lots of time and effort had I used a longer type basin where the lengths of aluminum could be totally submerged in the solution. Naturally the same applies for the rinsing process. Using Alumibrite is really very easy. I used a soft cloth to gently apply the cleaning solution to the surface of the aluminum, then rinsing the solution off with clean water. All the dirt seemed to pop right off!

The great thing about this solution is that it did not affect any of the non aluminum components of the antenna.

For instance the printing of the labels of the traps were 100% in tact after the cleaning the antenna. Later on I used a drop of Turpentine later on to clean a small paint spot from the boom and it immediately also removed some of the printing on the labels which was "spared" by the cleaning solution. Although I dried the aluminum with a soft cloth after rinsing, I allowed it to drip dry for a day or two.

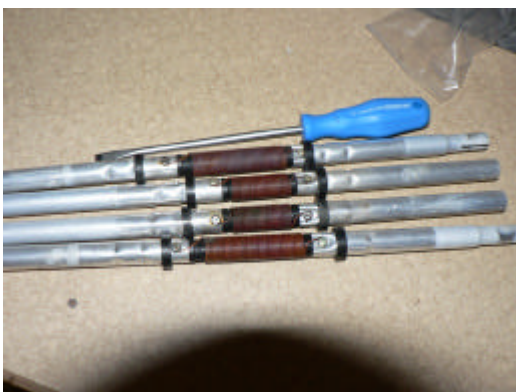
I cleaned all the brackets with normal soap and water which restored them to an almost original condition.

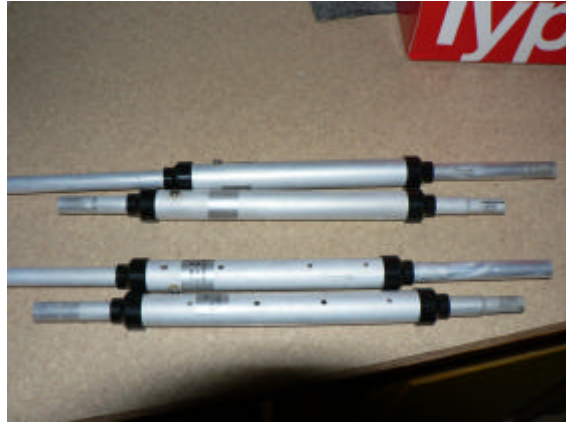
Replacing the Plastic Caps is much easier than getting hold of them. It is however extremely convenient having all the plastic components in one package. I found a reasonable comprehensive kit specifically made for this task supplied by Hy-Gain on their web site. It's called PK-TH3JR-PLS. Place your order for the kit well in advance as it takes at least 1 month to import. The plastic rings that can be seen on both sides of the open traps shown in the picture are not included in the plastics kit. I inspected all the rings and found that they were all as good as new – They are covered by the trap housing and unless they got lost, I cannot see you having to replace them. It would however have been a nice touch had Hy-Gain included a few of these rings in the kit in case some had to be replaced.

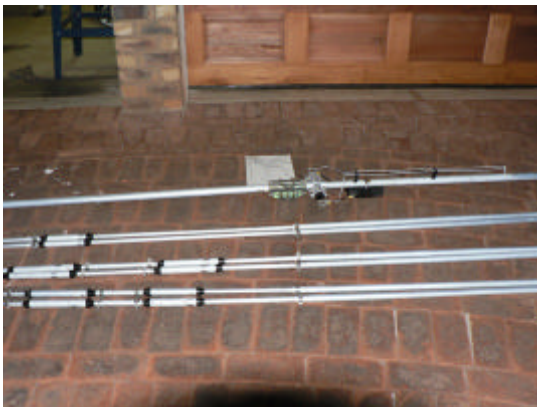
Once all the pieces were cleaned, rinsed, dried and re-assembled the beam was reassembled. It's important to ensure that the traps are clearly marked to enable you to easily identify the different traps as they are not all equal in size. Despite the fact that the markings of the original measurements were still visible I decided to re-do all the measurements from scratch using the Instruction Manual.

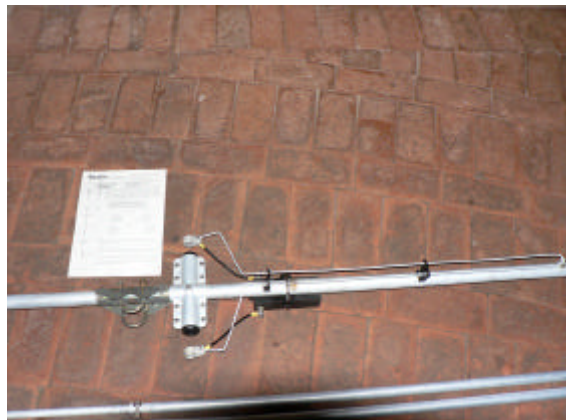
Final assembly and testing is done in the back yard on a small 3M tower. A MFJ 269 HF/VHF/UHF Antenna/SWR/RF Analyzer was used to check that the SWR on all bands were acceptable.
